Finance Committee Meeting

City Hall Exterior Repairs

SUBJECT: CITY HALL EXTERIOR REPAIRS

Community Building Exterior Repairs

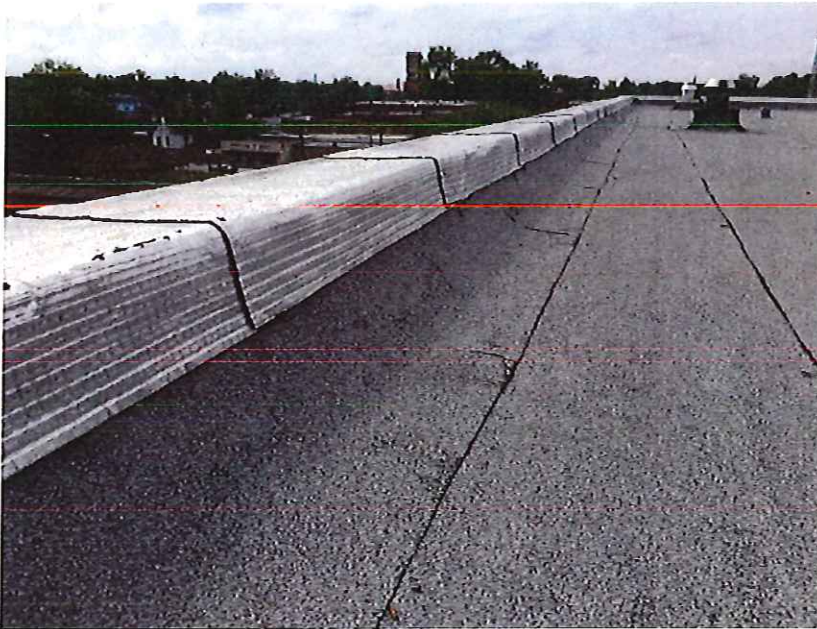
**Photo 4**

The perimeter of this roof system has a short parapet wall around it with mod bit flashings and metal edge. All of the base flashings appeared to be in good condition.

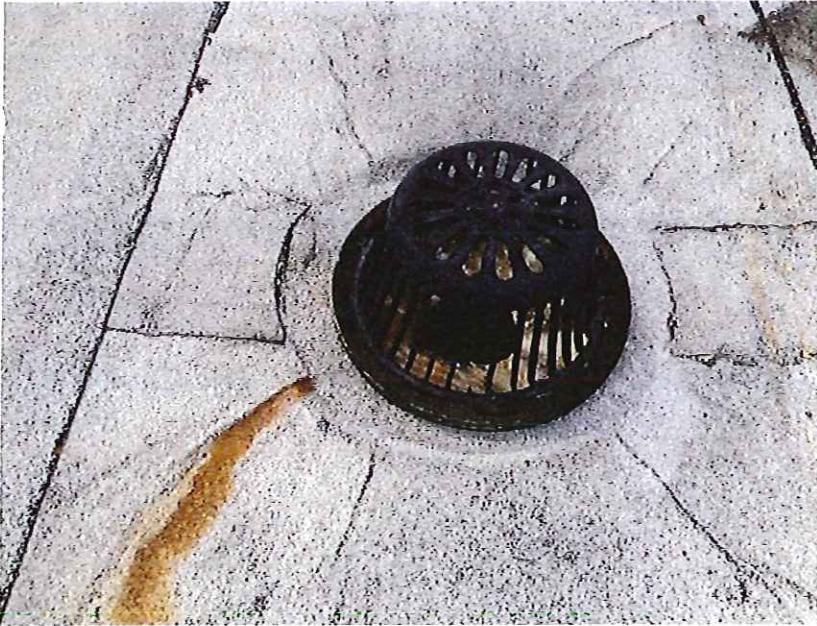
**Photo 5**

This is one of two primary roof drains for this roof area. This roof drains internally in the middle of the roof.

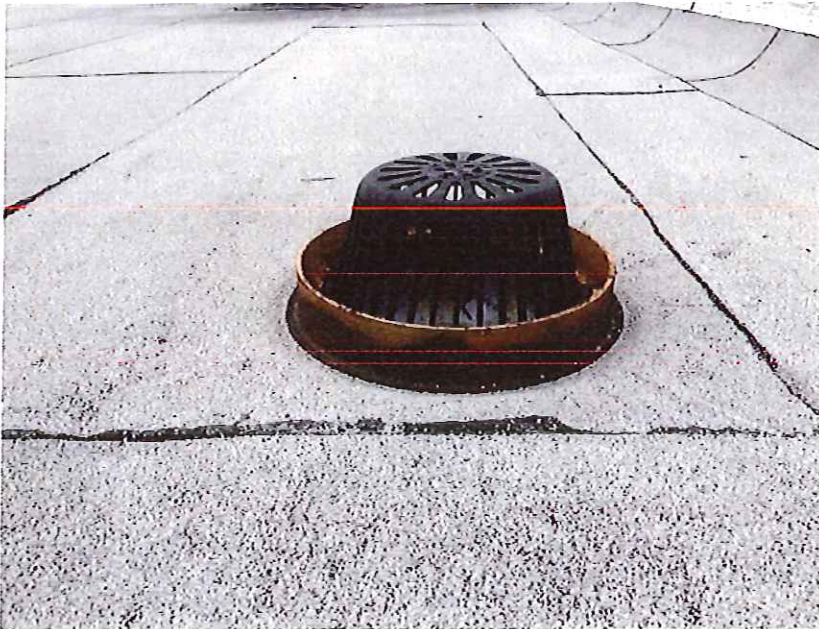
**Photo 6**

This is one of two overflow drains for this roof system. If the primary drains ever fail or clog these will drain the roof.

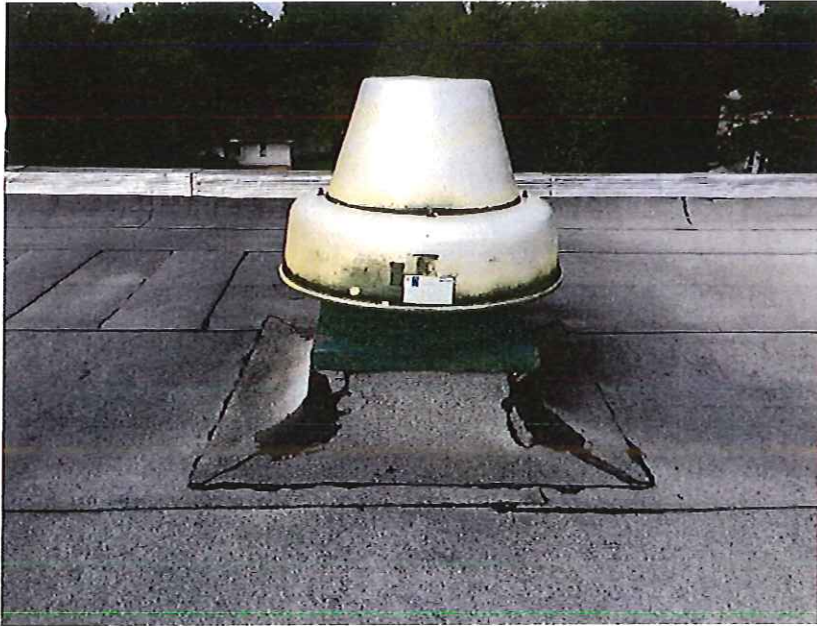
Photo 7

A typical fan and curb for this roof section.

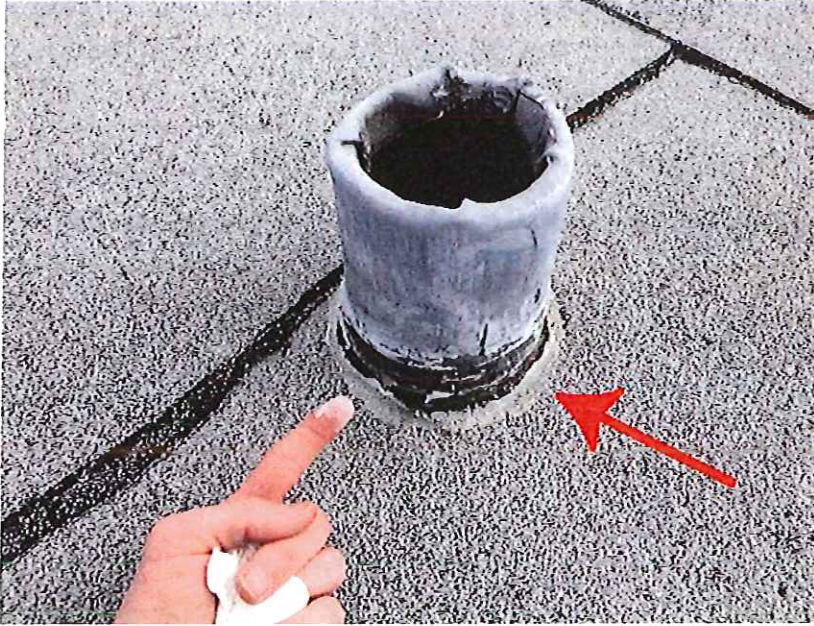
**Photo 11**

The sealants around the pipes and penetrations has dried up and pulled away from the substrate. This is a maintenance item that requires attention every so often.

- 3 Remove the dried failed caulking from the bases of pipes, heat vents, and penetration pockets. Reseal them using a Tuff Stuff MS urethane sealant.
- 4 Remove all repair/maintenance debris from the site.

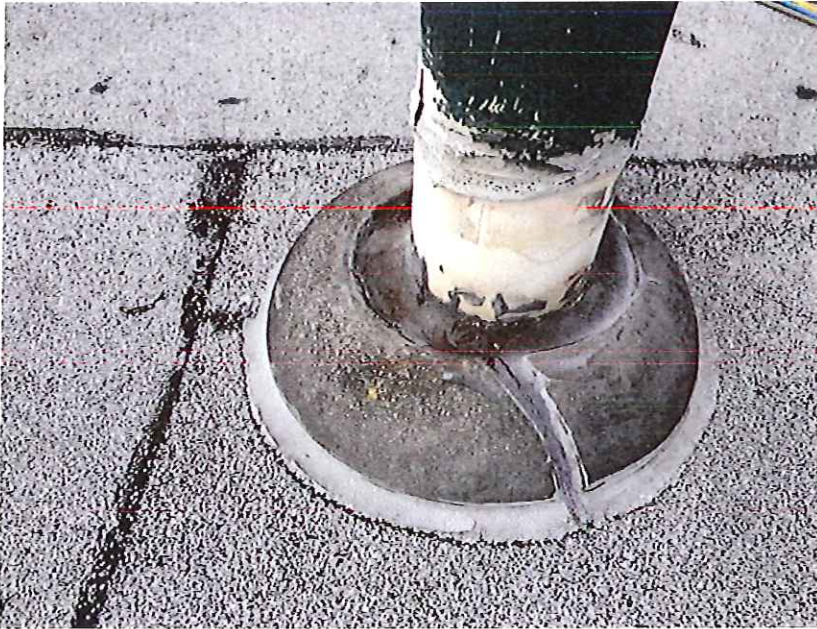
**Photo 12**

The penetration pockets appeared to be in good working order and free from cracks.

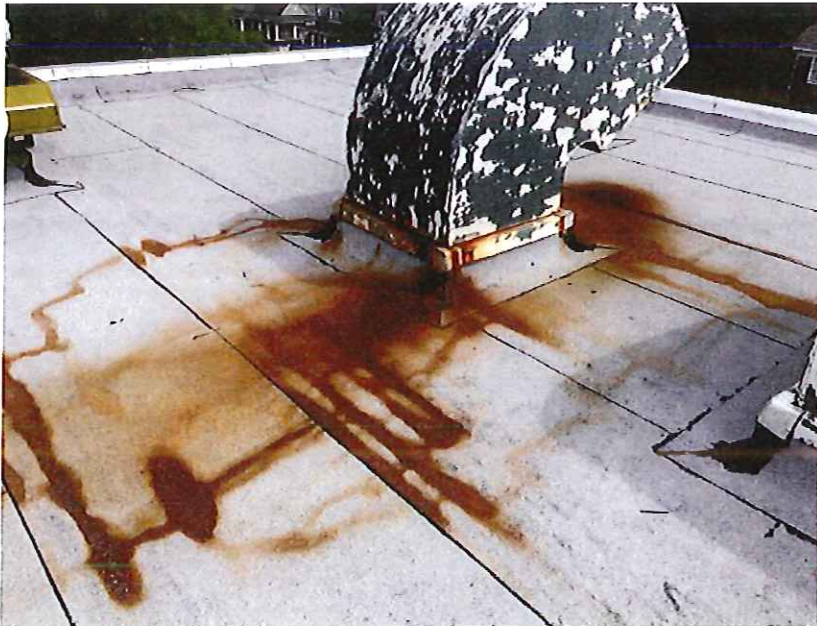
**Photo 13**

There are three vents/curbs like this one that are severely rusting and staining the roof membrane.

1. Prep the metal by wire brushing and scraping all loose and flaky paint or rust off to remove all loose paint, dirt, and debris from the vents. Clean the entire metal vents with rags a solvent based cleaner to remove any final dust and debris.
2. Caulk any cracks or openings larger than an 1/8th" using a urethane sealant.
2. Prime the metal with a Rust-Inhibitive Primer at a rate of .25-.5 gal per square in one coat. Allow the primer to dry.
3. Coat all metal with a White or Gray Top Coat at a rate of .5 gal per sq per coat with a two coat application.
4. Remove all restoration materials and debris from the roof and properly dispose of them.

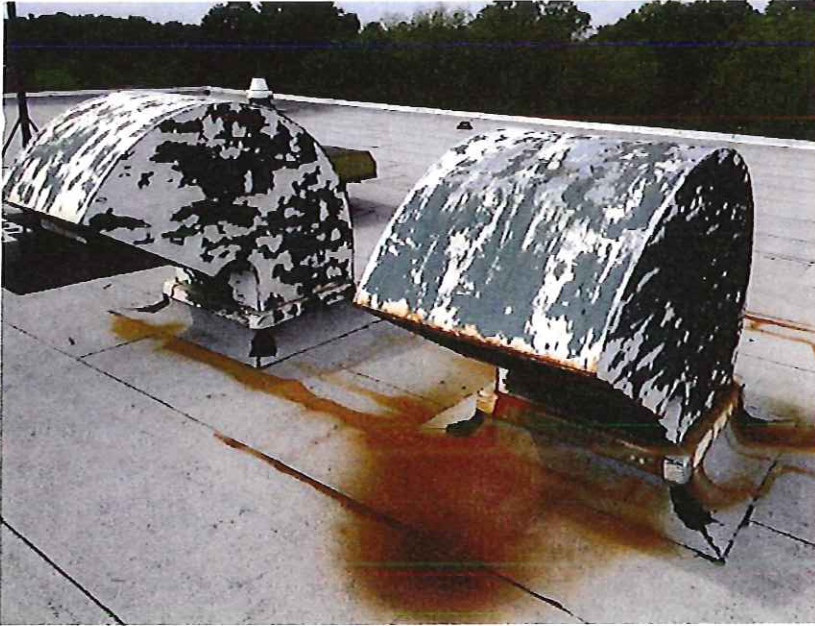
**Photo 15**

The paint on the three units is flaking off pretty much all over and the curb tops are rusting severely. Restoring these metal vents would be beneficial to the roof and the vents long term life.

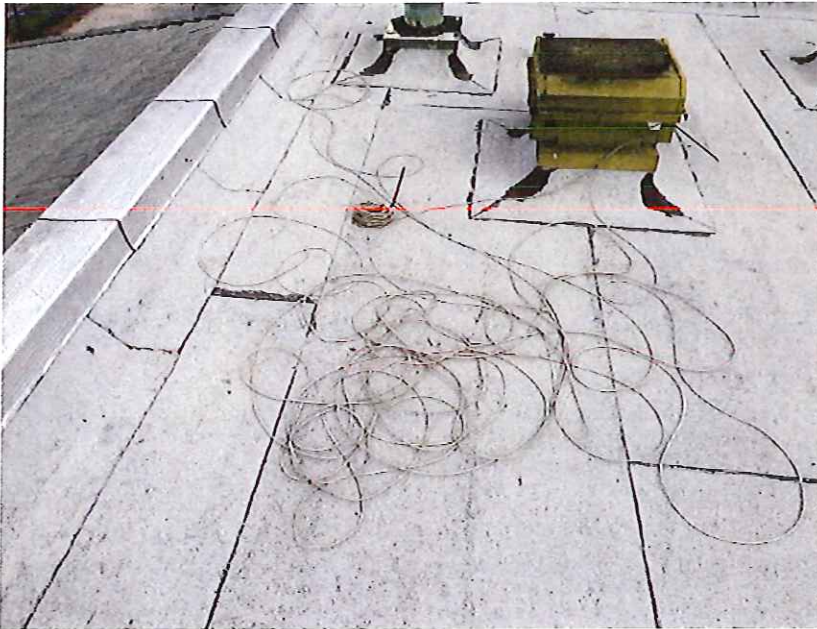
**Photo 16**

Try to identify wiring on the roof and label/store it off the roof to prevent tripping and possible roof damage.

1. Remove any and all debris from the roof surface to include walk pad pieces and abandoned wiring.
2. Repair the couple of open base flashing laps using a three course repair with aluminized asphalt cement reinforced with fiberglass mesh.
3. Remove the dried failed caulking from the bases of pipes, heat vents, and penetration pockets. Reseal them using a urethane sealant.
4. Remove all repair/maintenance debris from the site.

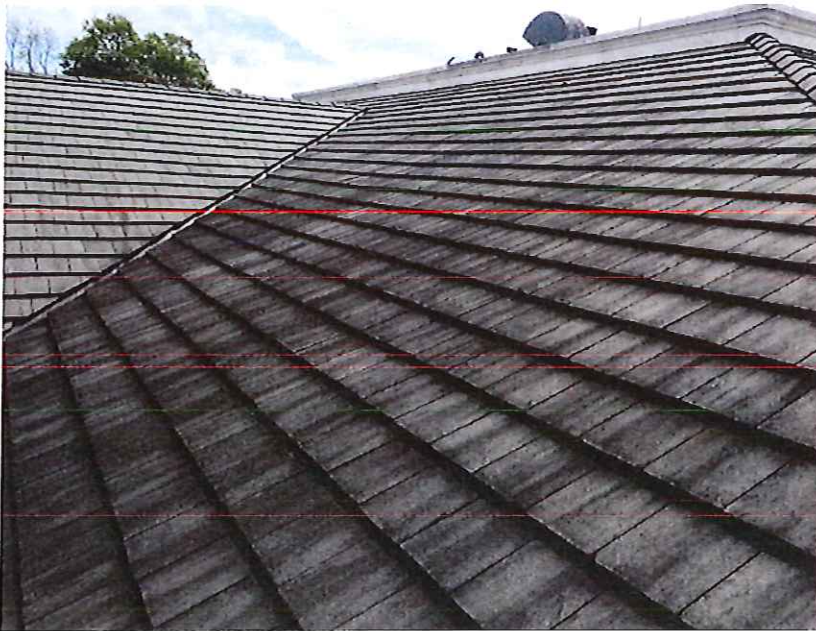
Photo 4

The tiles are staining from the elements. While they could be cleaned, walking on them to clean them might damage them.

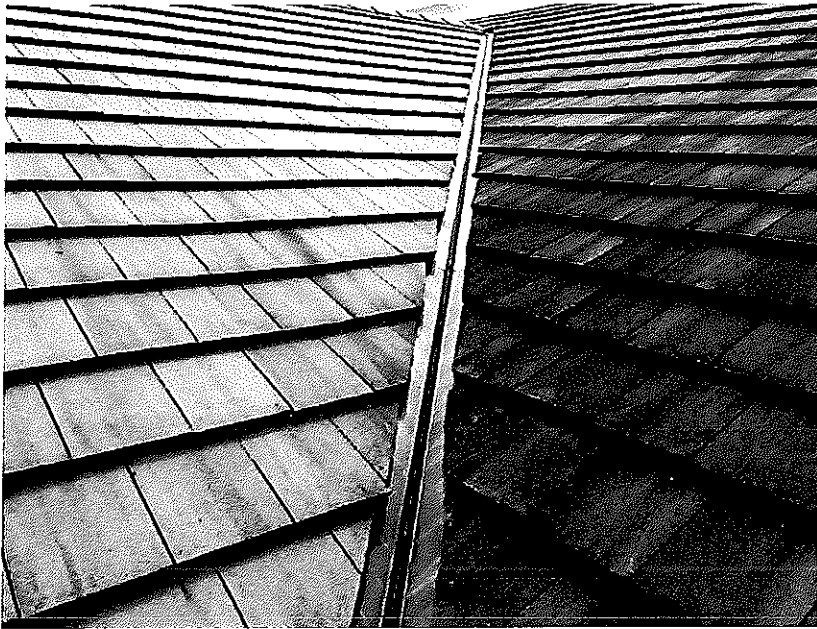
Photo 5

All valleys on this roof are made of metal and are free of rust.

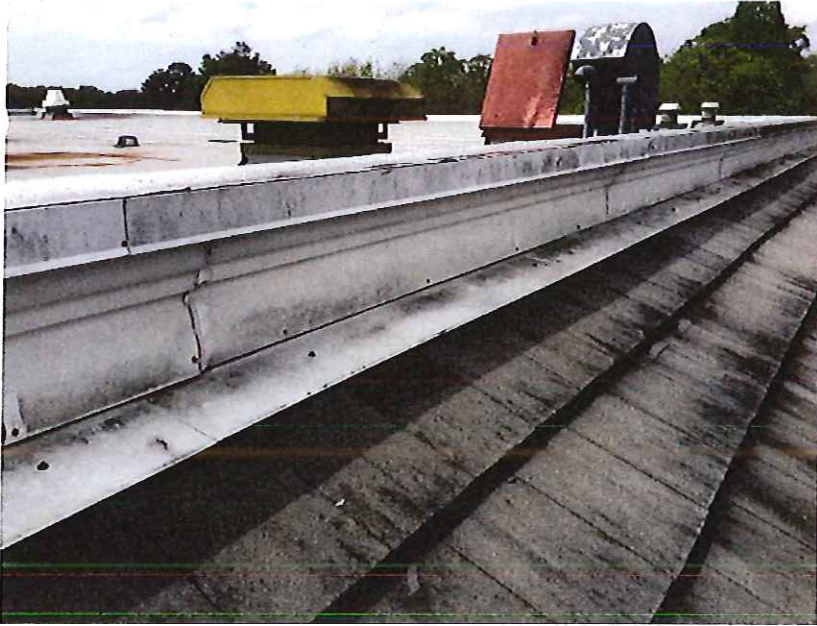
Photo 7

The exterior wall trim and counter flashings are stained and the paint is flaking in some areas.

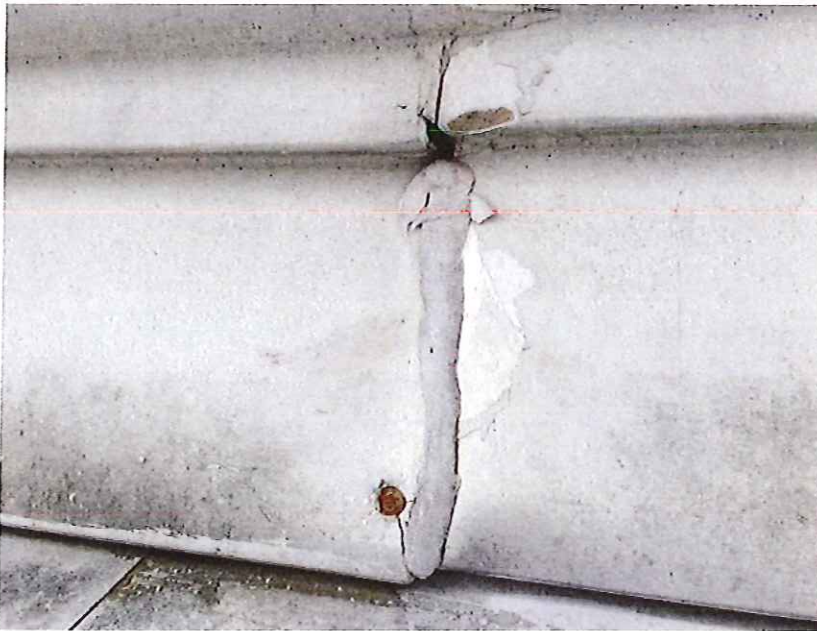
Photo 8

There are failed joint sealants in several areas on the trims around the exterior. These are water entry points that can cause damage.

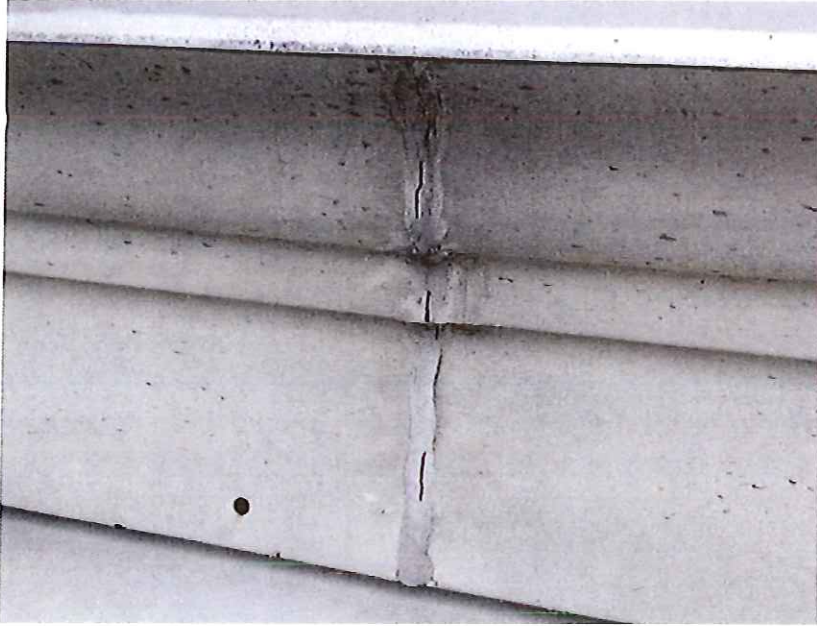
Photo 9

Another view of a joint in need of resealing.

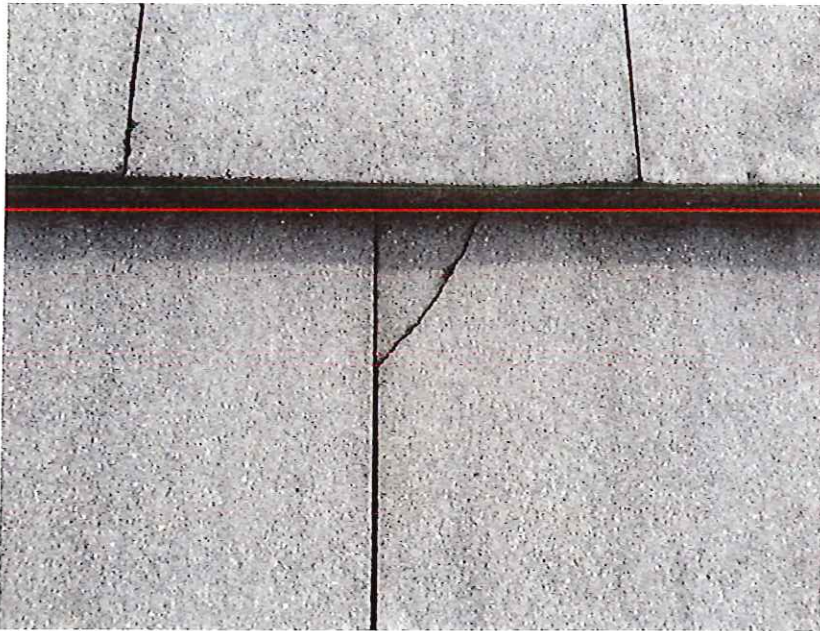
Photo 10

There were only a couple of cracked tiles found during the assessment. It does not appear to be causing any leaks at this point so these areas should be monitored.

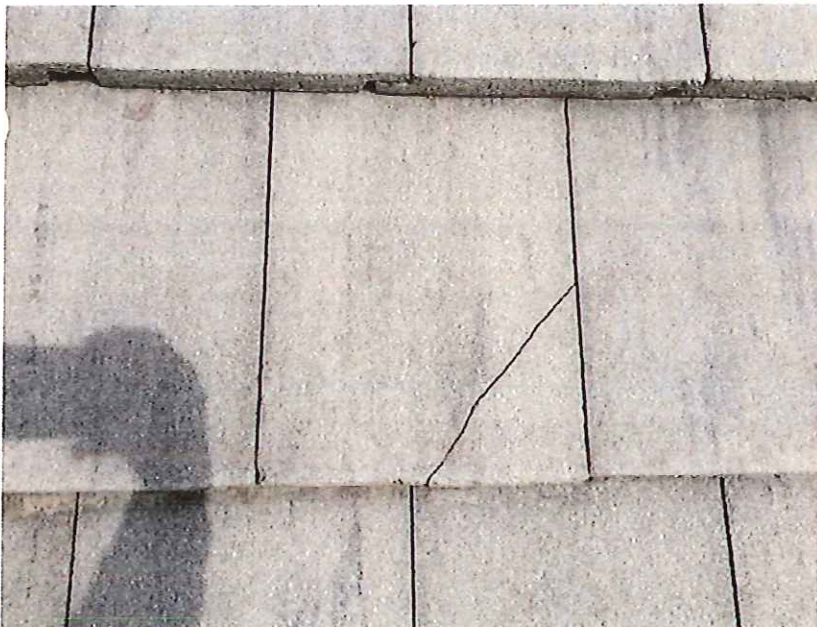
**Photo 11**

This cracked tile has the bottom corner cracked. This could slide down and fall off the roof if not repaired. Instead of replacing the tile, a structural adhesive could help hold it in place.

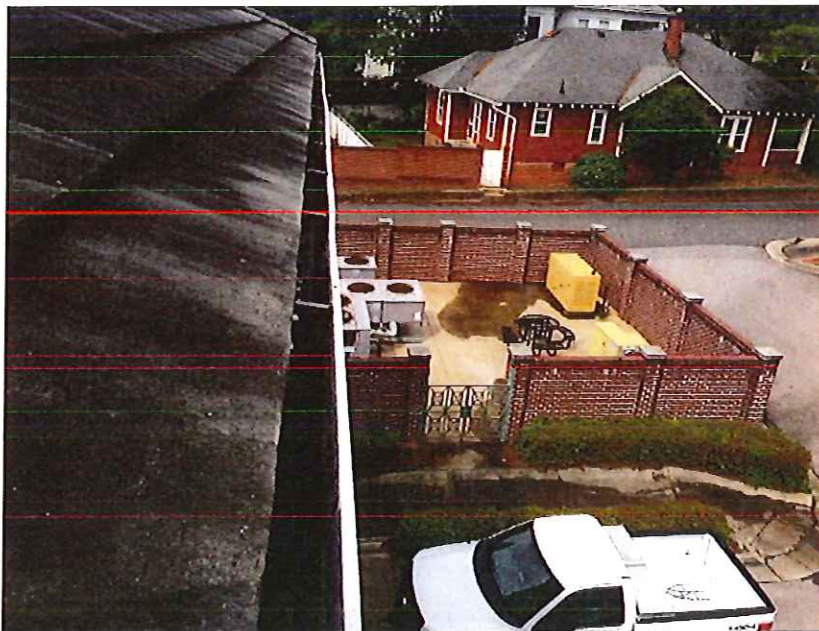
**Photo 12**

This section of roof all drains to a gutter and downspout system around the perimeter of the roof system. There did not appear to be any rust in the gutter at this time.

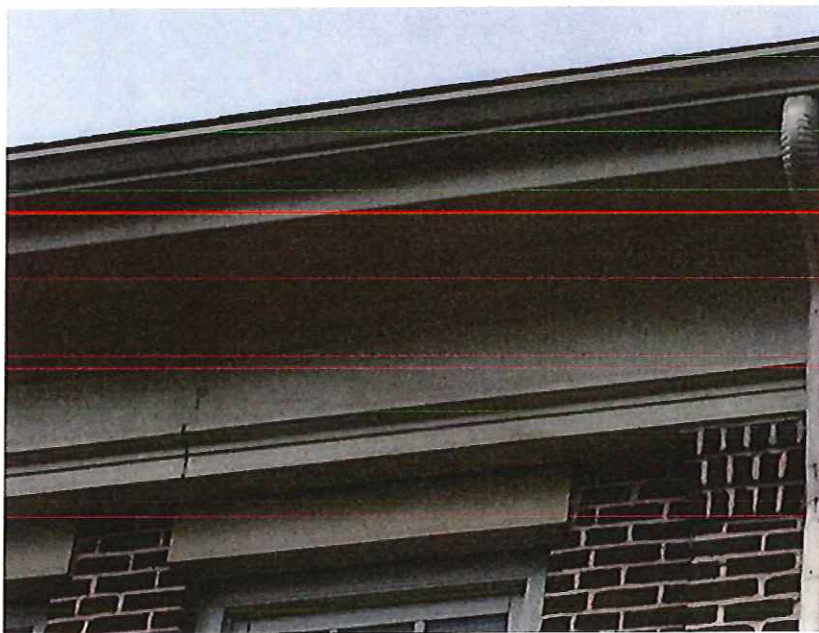
**Photo 10**

The exterior trim joints have opened up due to building movement and the paint is flaking in some areas. An exterior cleaning and painting should be budgeted for the future.

7. Prime all wood trim with the proper exterior primers.
8. Paint all trim and soffits using a desired exterior paint in the desired color.
9. Prime the decorative metal railings with a rust inhibitive primer to prevent further damage.

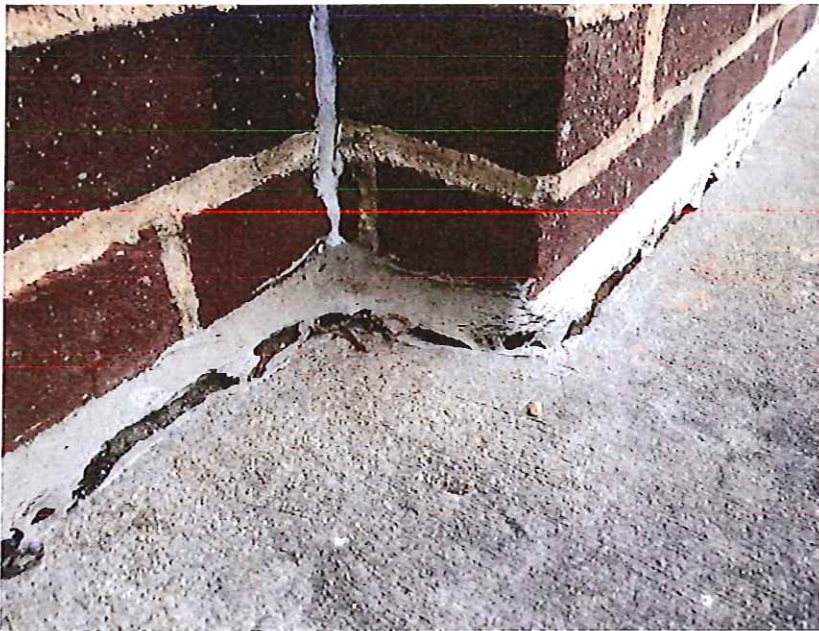
**Photo 14**

A close-up view of the ground joint that has failed. This joint is only on the rear of the building where the sidewalk is.

12. Cut out and reseal the sidewalk/building joint on the rear of the building to prevent water entry to the basement.

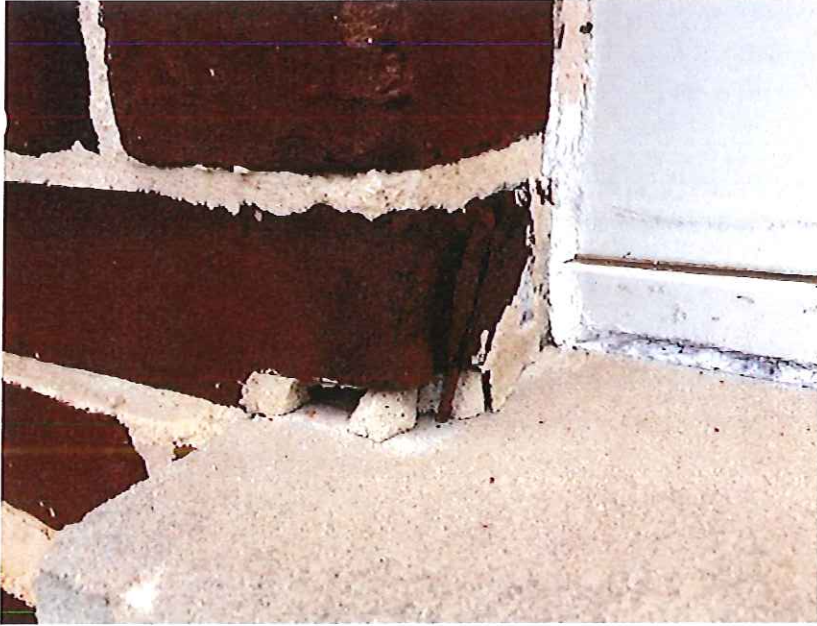
Photo 15

A minor masonry crack in the brick and grout joint.

3. Make any repairs need to cracked bricks and grout joints using a urethane sealant or grout to match if the area is large enough.
4. Cut out all the failed joints around the window frames.

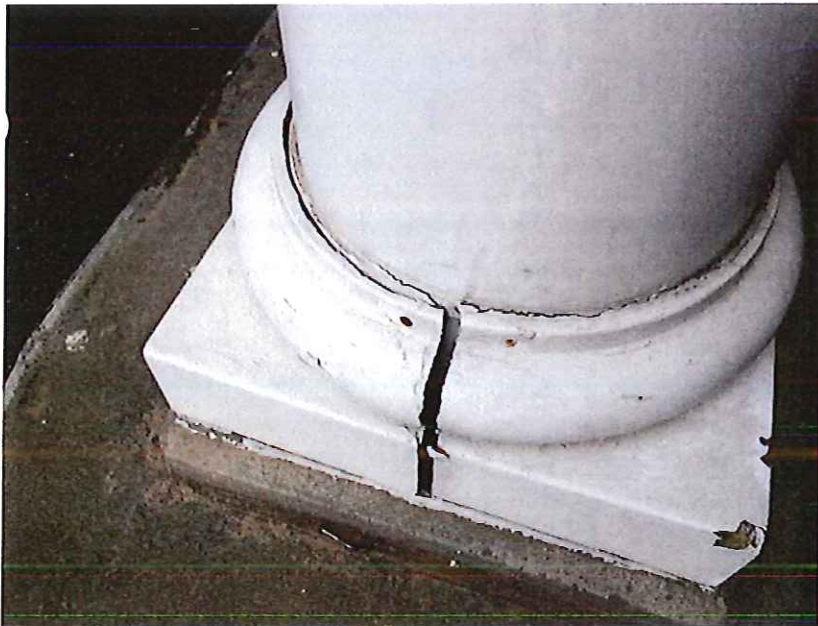
**Photo 17**

The base of this column has split. This is another area that can be repaired during a future exterior project.

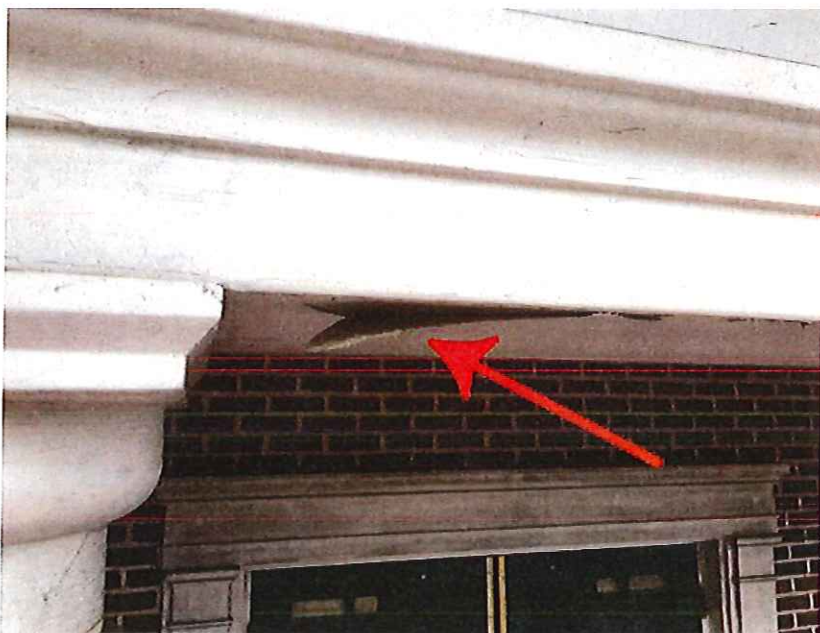
**Photo 20**

The paint of the front canopy trim is peeling in several areas. There does not appear to be any rotten wood yet.

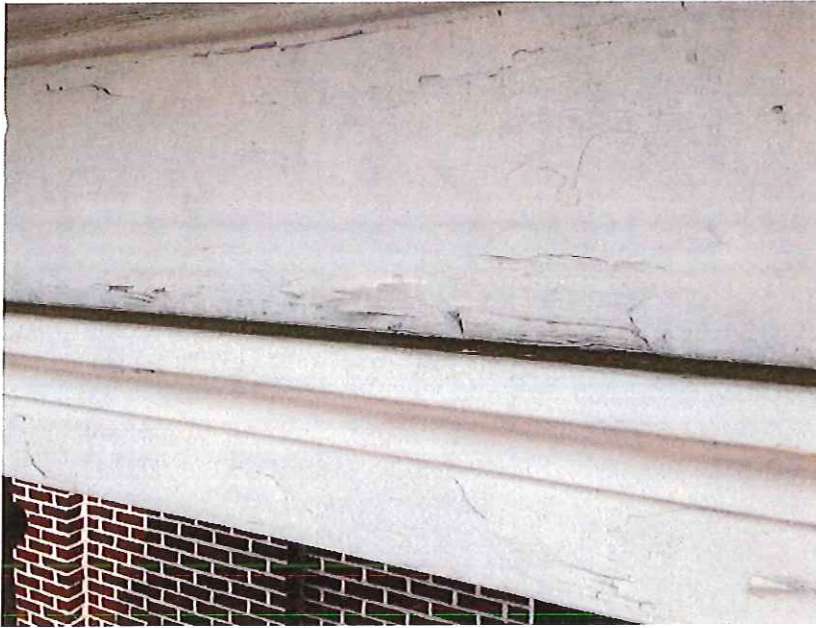
**Photo 21**

Another area of peeling paint. The wood is not damaged yet and could be repainted without wood replacement.

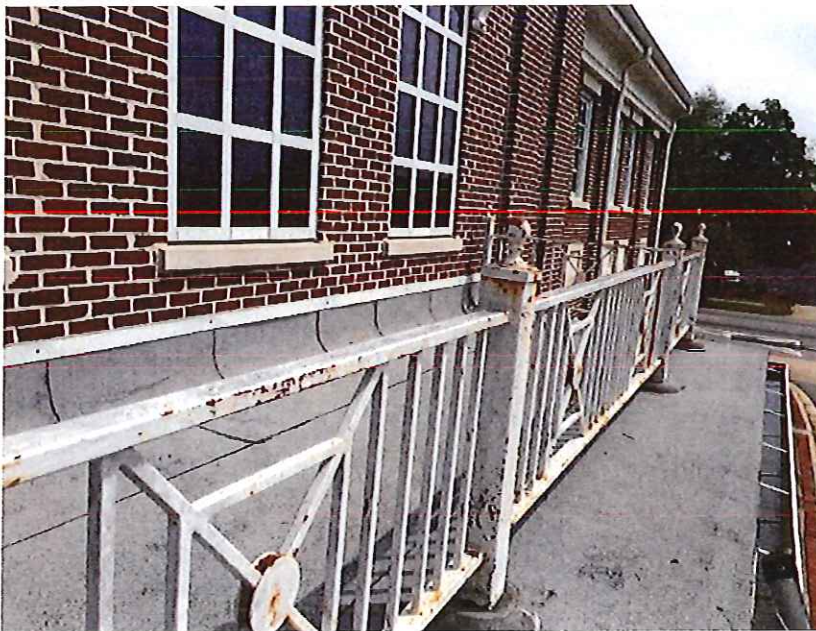
**Photo 22**

A view of the metal fence on the front canopy. The paint has deteriorated and the metal is rusting now in many locations. To prevent further damage this should be repaired.

10. Recoat the metal railings with a white top coat for metal at a rate of .5 gal per sq.
11. Replace the damaged downspout on the front with a similar round downspout to match the existing.

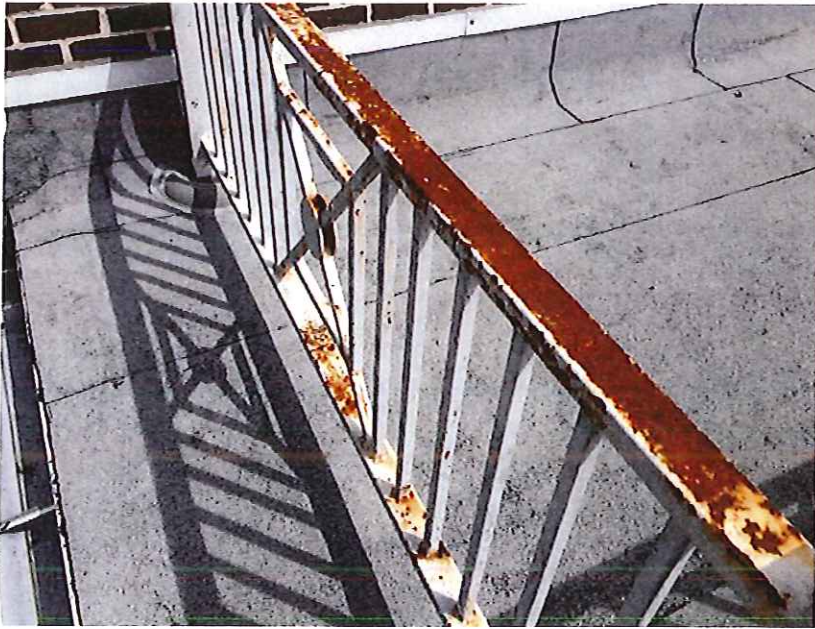
Photo 23

A view of the rusted areas. All rust can be removed before recoating the metal.

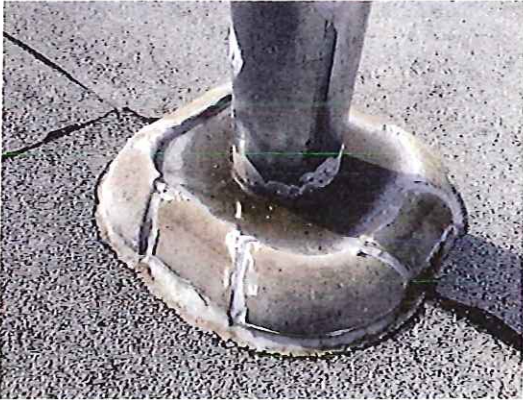
**Photo 5**

There are only a few pitch pans on the roof and they have settled a little. This allows them to hold water and can lead to premature failure and leaks. During routine yearly maintenance, this should be crowned with sealant.

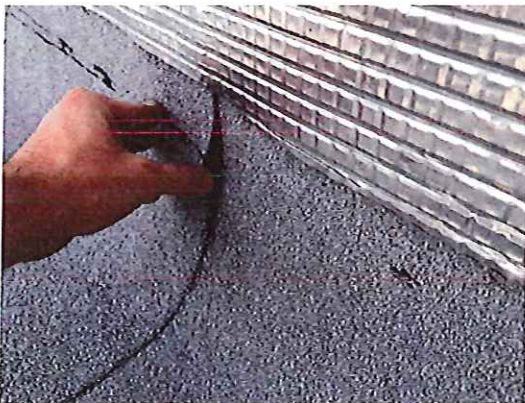
**Photo 6**

There were a few minor open flashings found that should be three-coursed before they get worse.

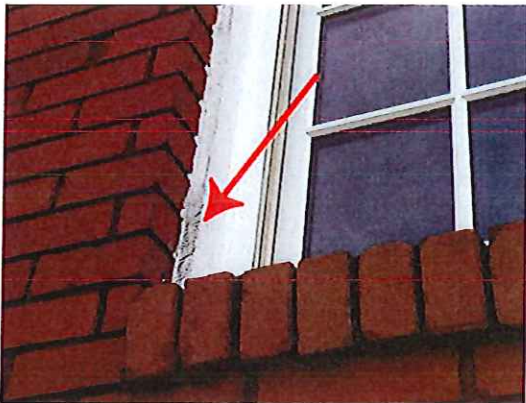
**Photo 6**

Another example of a failed window joint, this example is on the second story window.

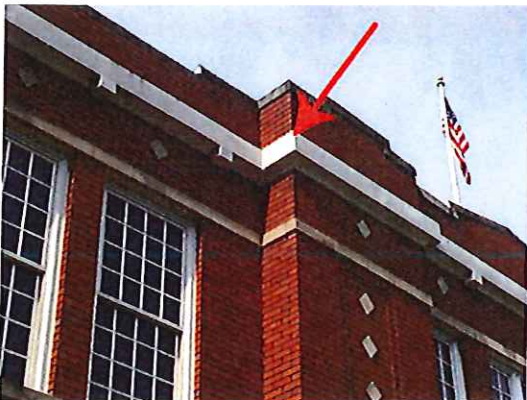
**Photo 7**

This metal band runs the front length of the building. The paint is peeling in several areas and the metal is showing signs of rust in some areas. The maintenance team said it was just painted a couple of years ago and its already peeling.

- 1 Seal the existing reglat metal above the metal using Greenlock XL sealant.
- 2 Pressure wash all metal railings and the high front metal trim using simple green cleaner solution. Use a wire brush as needed to remove loose paint.
- 3 Coat the metal with Rust-Go Primer in one coat, at a rate of 1/4 per square.
- 4 Coat the metal with Rust-Go Top Coat white in two coats, at a rate of 1/2 gal per sqare per coat.

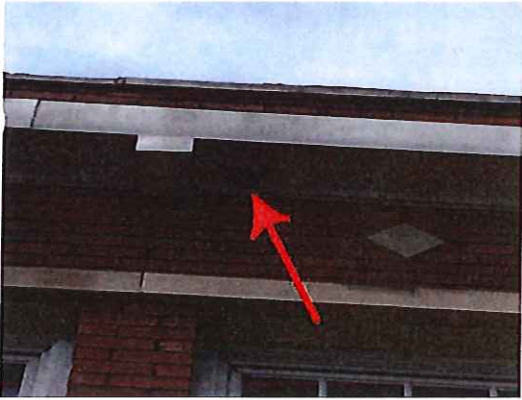
**Photo 8**

A view of the peeling paint on the metal facade trim. This is usually an indicator of either the wrong type of paint or poor prep work and priming.

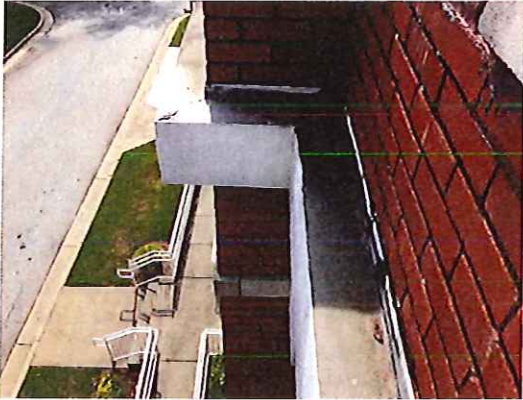
**Photo 9**

The paint installed a couple of years ago, was not applied on top of the metal trim. As seen here, some water sits on the ledge and is beginning to rust the trim.

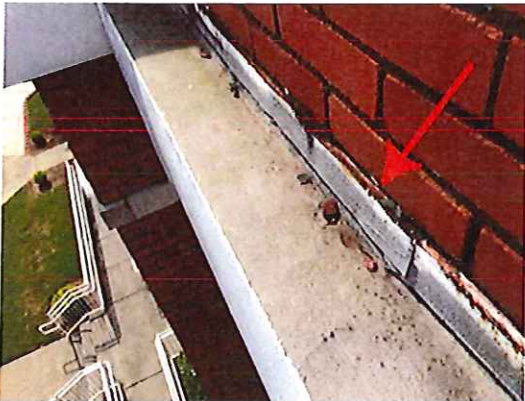
**Photo 10**

It was noticed during the assessment that the reglet metal flashing here is very loose and allowing water behind it. To prevent damage and water entry, this should be resealed.

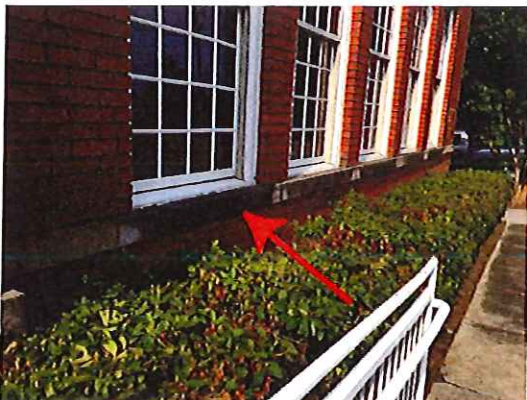
**Photo 11**

The precast masonry moldings are stained and black from water soaking in and drainage. This can be remedied and prevented from returning.

- 1 Pressure wash all Cast Concrete using simple green cleaner solution.
- 2 On heavy stains, use B-Clean masonry cleaner as needed.

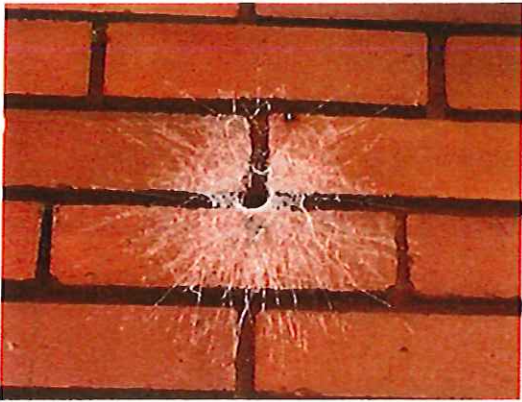
**Photo 12**

This spider web shows an area of missing brick grout allowing not only spiders but water to enter the building.

- 2 At large open joint at ground level at back of building, fill with appropriate backer and seal using Greenlock Sealant XL.
- 3 At cracked or separated mortar joints, provide the following scope:

- a Mechanically remove up to 3/8" inch depth of mortar.
 - b Blow or Vacuum out joints prior to replacement.
 - c Neatly repoint all removed mortar joints with Garland Gar-Rock or Type-S mortar.

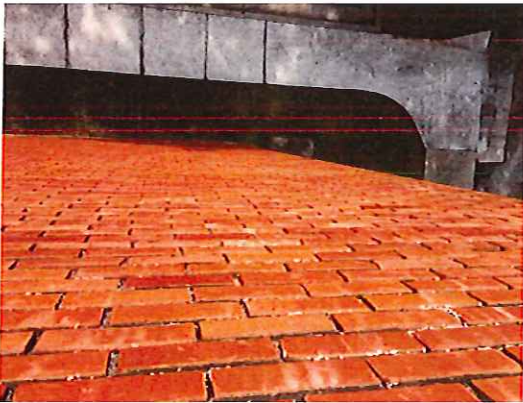
**Photo 14**

This view shows some signs of efflorescence on the brick walls. This is caused by water getting behind the brick and then exiting through the brick and deposited the salts and minerals on the exterior.
